# Bring Digitalization to an Enhanced Urban Transportation

Lizuo Xin, Emilio Tuinenburg, Danny Meringa, Siemens Mobility B.V., the Netherlands.

*In this paper a use case of root cause analysis (RCA) of a subsystem disturbance (false notification of section occupancy) based on the gathered data, is presented. The use case is taken from the Randstad Rail in the Netherlands, which is the light rail network in the southern part of the Rotterdam – The Hague area. Due to the high population in the area, the low downtime of maintenance is requested to ensure the passengers a safe and punctual journey.*

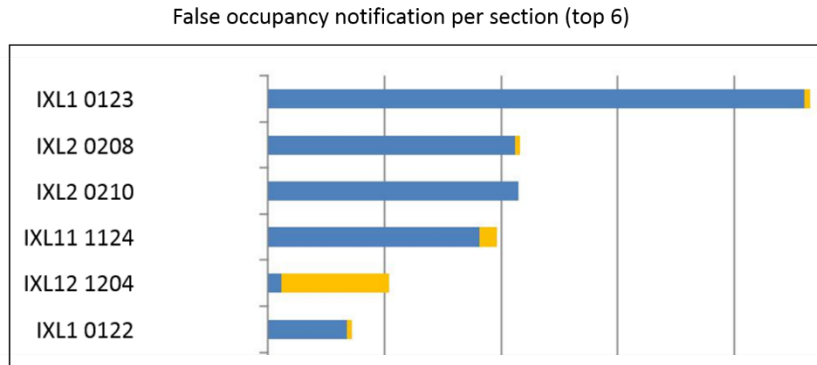
Figure 7. Failure history of top 6 sections (with most false occupancy notification). Notification in blue: during the operating time; notification in yellow: outside the operating time [2]

Investigation of the data from Jan 1st 2017 to June 30th 2017 has revealed that most TOBS are related to a few specific sections (Figure 7). The data source used here is the 'btb file', which contains the operator command of axle counter reset.

Section 0123 is located at the border of two interlocking controlling area. As the adjacent section belonging to the other IXL has very few TOBS message, the border axis counter can be excluded as a potential source of interference.

Therefore, Section 208 and Section 210 have the most TOBS; the axle counter connected the two sections is investigated. According to maintenance record of this axle counter, it can be seen that many activities have been performed, such as checking the cables on both counting head side and the IXL side. However, many attempts fail to solve the problem; only reconnecting the cable via the neighbouring axle counter to the IXL seems to work, which is however considered as a temporary solution [2].

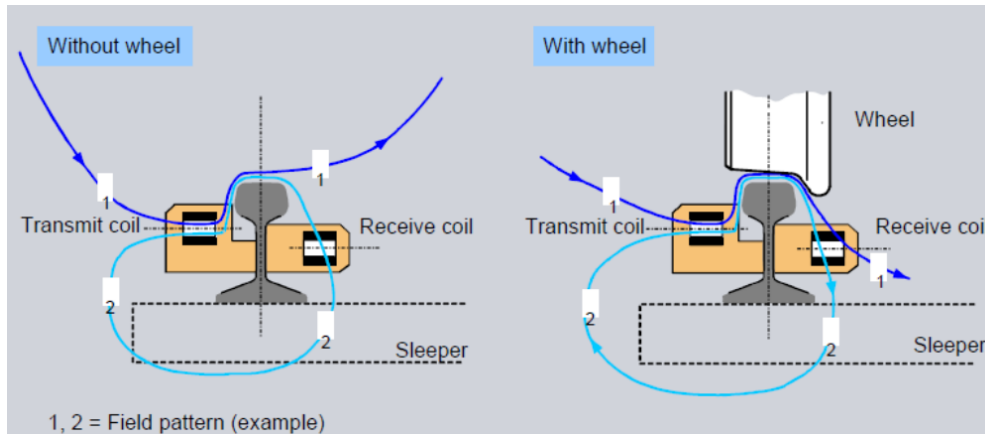
Figure 9. Mechanism of detecting a wheel passage by the axle counter [4]

According to the investigation mentioned above, the focus is now the possible incorrect detecting of wheels of those vehicles. One idea is that the false interaction of the wheel and rail. Due to wear and tear on the rails and/or wheels, the profile of the rails or wheels may have severely changed. When the wheel passes the axle counter, the magnetic field could not be correctly received by the receiver of the axle counter (Figure 9). As a result, an incorrect count is made.

The receiver's failure to receive or process the magnetic field correctly may be caused by [3]:

- Reception coil, cables, peripheral electrical components and interlocking do not work to specification.
- The rail controls/affects the magnetic field so that the magnetic field is not received by the receiver coil.
- The wheel controls/affects the magnetic field so that the magnetic field is not received by the receiver coil.
- A combination of the above-mentioned causes.

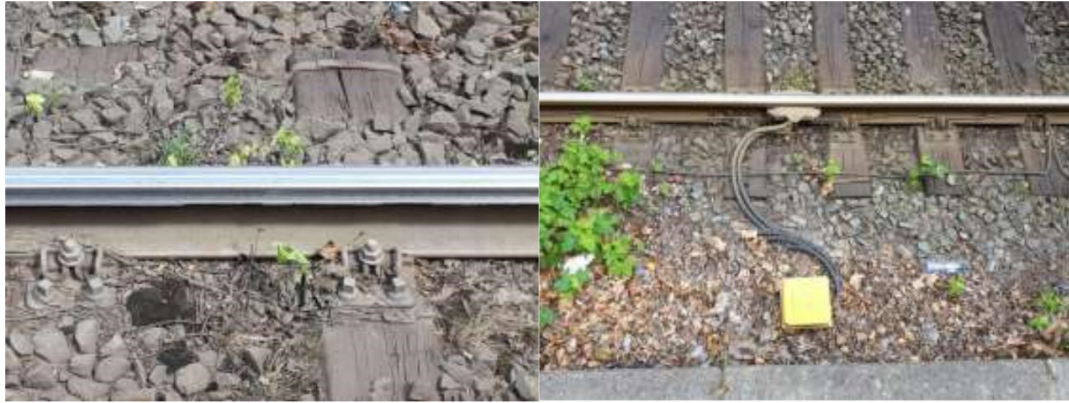
Figure 10. Track condition of section 208 and 210 [3].

It has been found out that the average minimum flange thickness is significantly lower for the vehicles causing TOBS compared to the average minimum flange size of the whole fleet, 15.8mm and 18mm respectively. 100 out of the 109 TOBS reports concerned a minimum flange size smaller than 17 mm.

It has been found out that in this case TOBS is caused by the fact that the two axles of one bogie are not measured correctly. Correspondingly, the vehicle has relatively small wheel flanges on bogie.

The picture (Figure 10) on the left shows worn rails. As a result, for vehicles with a relatively short flange height, the magnetic field does not deviate sufficiently and is therefore not received by the receiver. For this reason, the axle counter was temporarily moved to the other rail. Here the wheel flange has a correct interaction with the rail, so that the magnetic field is received by the coil. For track replacement, the axle counter is rebuilt in its original configuration.

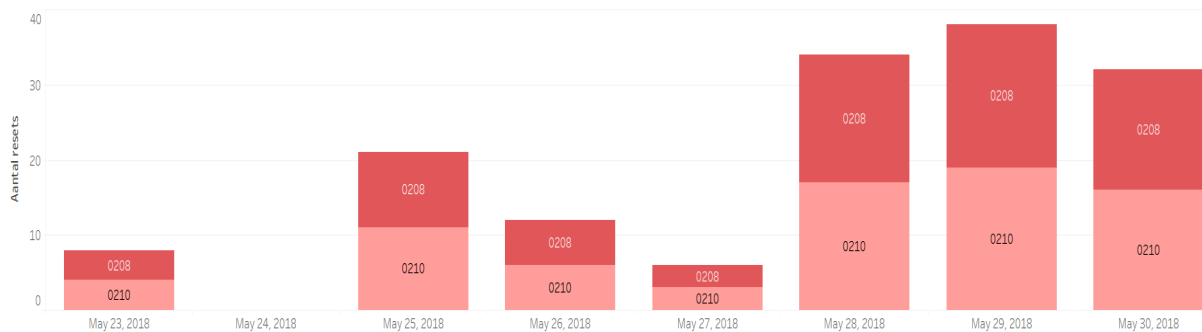
Figure 11. Example of data visualization: number of axle counter reset on section 208/210.

One important aspect of the 'bring data to life' is the data visualization. With the help of the tooling, disturbance of the field elements e.g. signals, points and sections are directly presented. The following figure (Figure 11) gives an example of the visualization of axle counter resets on section 208/210 in May 2018.
